# INVESTIGATION OF HULL EXCITATION CHARACTERISTICS ON CFAV QUEST

James L. Kennedy

February 1998

**TECHNICAL MEMORANDUM 97/208**

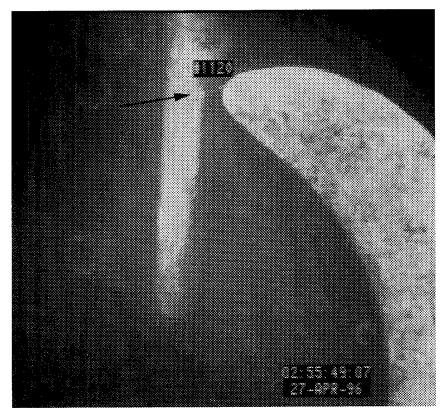
Figure 13 Propeller cavitation, looking aft, Run 1120

The cavitation at this condition was very intermittent. About 1 percent of the blade passes were estimated to have experienced cavitation. These were detected audibly. One pair of images in the complete run picked up a vortex leaving the blade tip in the wake peak. This can be seen in Figure 13, identified by the arrow at the blade trailing edge. It is also visible in the fuzzy area identified by the arrow in Figure 14. These were the only visual indications of cavitation.

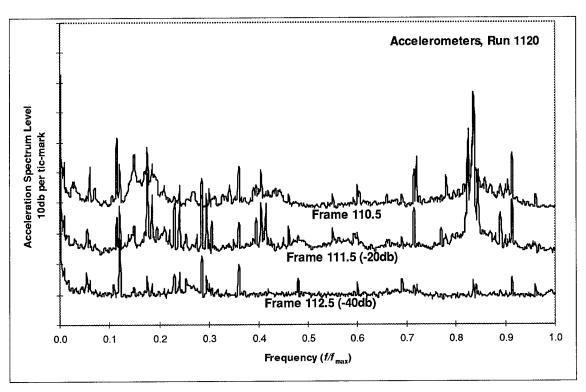
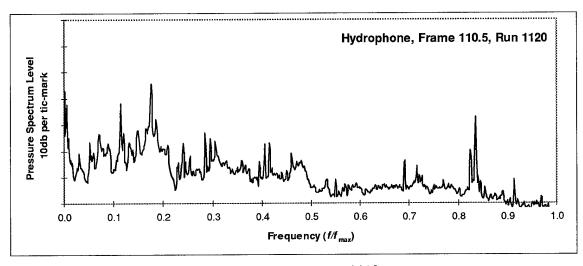
Figure 17 High frequency accelerometer data, Run 1120

There was no significant difference between the accelerometers' high frequency spectra for Runs 1120 and 1110. The hydrophone data for run 1120 showed a small increase, of the order of 2db, across much of the frequency band. This could be attributed to the cavitation.

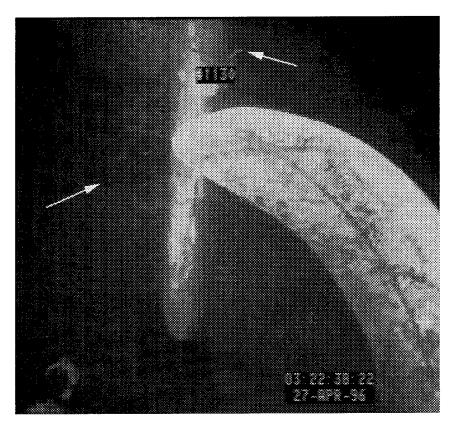
Figure 19 Propeller cavitation, looking aft, Run 1130

Intermittent vortex cavitation was observed on all blades at this condition. Two views of this can be seen in Figure 19 and Figure 20. These pictures indicate that the cavitation came from a leading edge vortex which detached from the blade, at close to the 0.98 radius fraction. The vortex is seen, as indicated by the arrows, in Figure 19, downstream of the blade, and in Figure 20, as a short line of bubbles. In Figure 19 an arrow indicates a vortex from the previous blade, cavitating in the wake peak, close to the rudder.

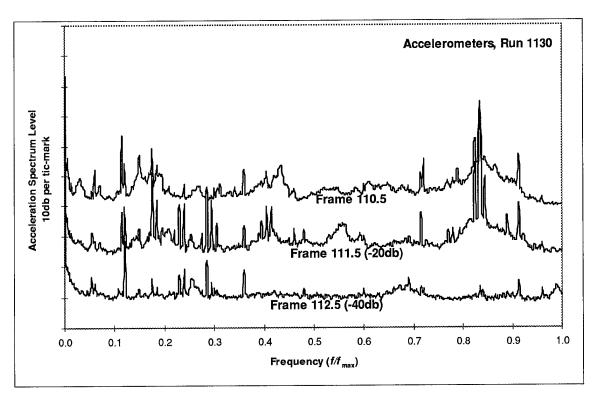
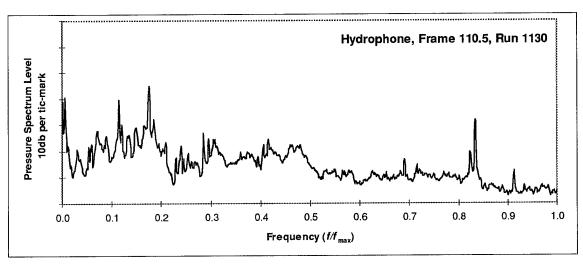
Figure 23 High frequency accelerometer data, Run 1130

At frame 110.5 there was an observable increase in both the acceleration and pressure levels over those of Run 1120. The hydrophone signal increased by about 2db in the frequency band from  $f/f_{\rm max} = 0$  to 0.3 and by about 5db in the frequency band from  $f/f_{\rm max} = 0.3$  to 1.0. The higher noise floor of the accelerometers at frames 111.5 and 112.5 hid this effect at these locations.

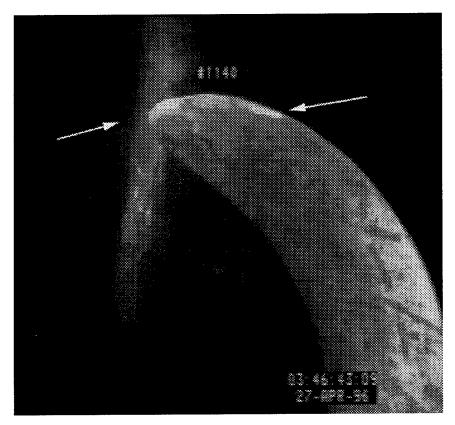
Figure 25 Propeller cavitation, looking aft, Run 1140

Intermittent cavitation was observed on all blades at this condition. Two views of this can be seen in Figure 25 and Figure 26. A leading edge vortex, which detached from the blade close to the tip, cavitated from the leading edge back, as shown in Figure 26. Even less frequently, a patch of sheet cavitation was seen on some blades, as pointed out by the arrow in Figure 25. This sheet started at approximately the same location as the vortex. The vortex cavitation was not always a fine line of bubbles, as in Figure 25 or in Figure 19. Occasionally it burst into a cloud of bubbles, as seen in Figure 26. There was also an indication of a vortex from the previous blade, cavitating in the wake peak.

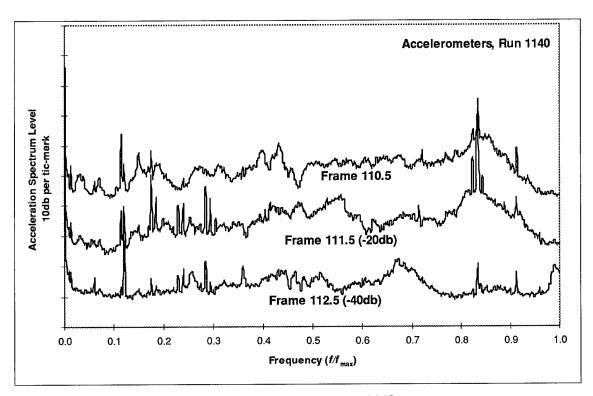
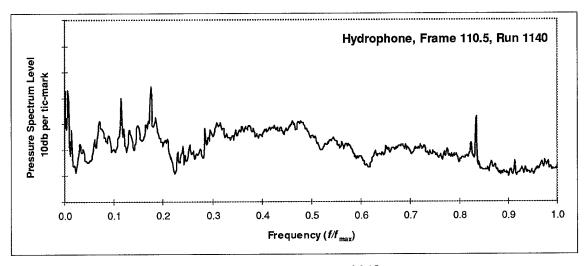
Figure 29 High frequency accelerometer data, Run 1140

The accelerations at frames 110.5 and 111.5 and the pressure levels showed a substantial increase over those of Run 1130. The accelerations at frame 112.5 showed a smaller increase, confined largely to the  $f/f_{\rm max}=0.3$  to 0.75 band. The hydrophone signal increased by about 3db in the frequency band from  $f/f_{\rm max}=0$  to 0.3 and by about 9db in the frequency band from  $f/f_{\rm max}=0.3$  to 1.0.

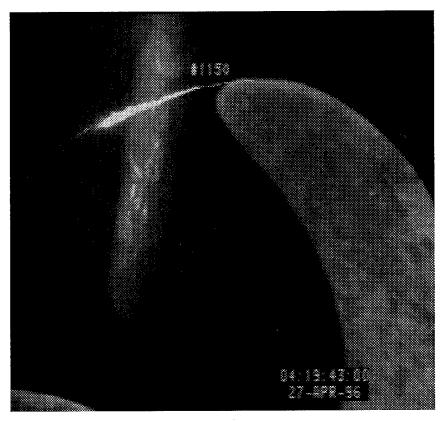
Figure 31 Propeller cavitation, looking aft, Run 1150

The leading edge vortex cavitation was seen consistently in this condition, and the sheet cavitation was intermittent, although it was on all blades. The sheet cavitation was confined to a region close to the 0.95 radius fraction. The maximum amount of cavitation happened in the wake peak and its growth and collapse showed a consistent pattern as the blade swept through the wake peak. Representative views of the cavitation are given in Figure 31 and Figure 32. Initially, sheet and vortex cavitation formed at the leading edge, as shown in Figure 32. A few degrees of rotation later, these cavities collapsed and most of the cavitation disappeared. Finally the vortex would begin to cavitate some distance downstream of the tip. The vortex cavitation usually burst into a cloud of bubbles, as seen in Figure 31. Occasionally vortex cavitation from a previous blade was seen bursting in the wake peak near the rudder.

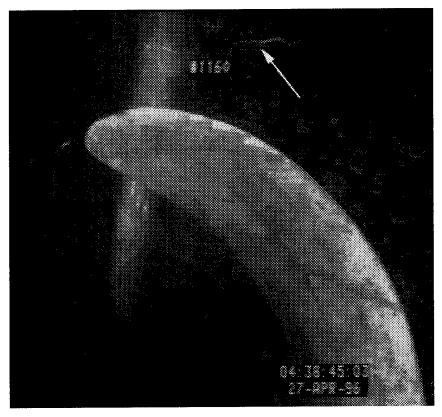
Figure 37 Propeller cavitation, looking aft, Run 1160

The leading edge vortex and sheet cavitation were seen consistently in this condition on all blades. The sheet extended down the blade to the 0.9 radius fraction. The sheet was frequently in separate areas along the leading edge as shown in Figure 37. The vortex cavitation frequently burst into a cloud of bubbles, as seen in Figure 38. Frequently vortex cavitation from a previous blade was seen bursting in the wake peak near the rudder. The arrow in Figure 37 points to such a vortex.

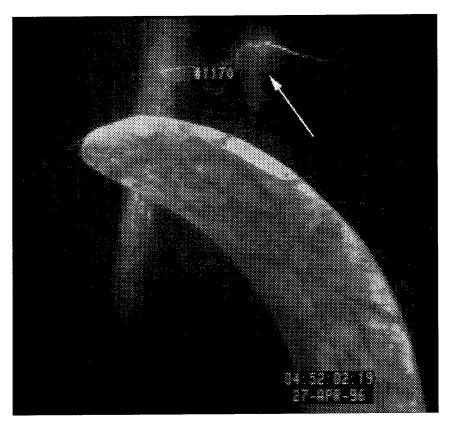
Figure 43 Propeller cavitation, looking aft, Run 1170

The leading edge vortex and sheet cavitation were seen consistently in this condition on all blades. The sheet extended down the blade to the 0.85 radius fraction. The sheet was frequently in separated areas along the leading edge as shown in Figure 43. The vortex cavitation usually burst into a cloud of bubbles, as seen in Figure 44. Frequently vortex cavitation from a previous blade was seen bursting in the wake peak near the rudder. Such a vortex can be seen bursting in Figure 43 as indicated by the arrow.

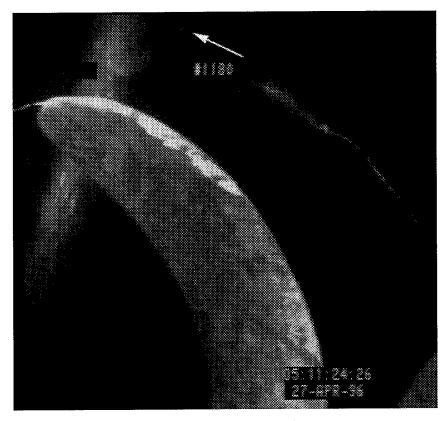
Figure 49 Propeller cavitation, looking aft, Run 1180

The leading edge vortex and sheet cavitation were seen consistently in this condition on all blades. The sheet extended down some blades to the 0.8 radius fraction. The sheet cavities were larger and less separated than in Run 1170, as shown in Figure 49. The vortex cavitation always burst into a cloud of bubbles, as seen in Figure 50. Also the vortex cavitation from previous blades burst in the wake peak near the rudder. Up to two vortices from preceding blades were observed at close to top-dead-centre. An arrow points out the furthest downstream vortex in Figure 49.

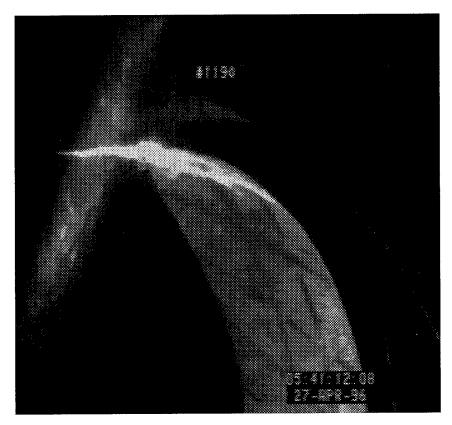
Figure 55 Propeller cavitation, looking aft, Run 1190

The leading edge vortex and sheet cavitation were seen consistently in this condition on all blades. By comparison with Run 1180, the sheet extended farther across the chord. The vortex cavitation arose from a complex combination of leading edge vortices and sheet as seen in Figure 55. After forming, this cavity would quickly burst. Also the vortex cavitation from previous blades burst in the wake peak near the rudder. Such a vortex can be seen bursting in Figure 55. At this condition a very intermittent hub vortex was occasionally observed as shown by the arrow in Figure 56.

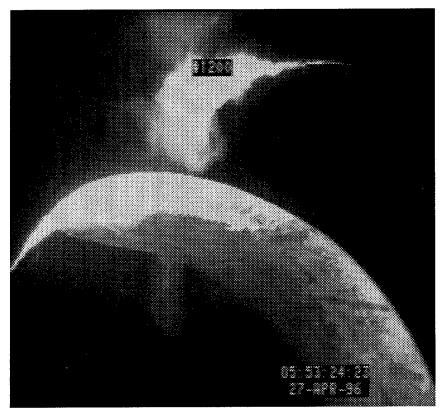
Figure 61 Propeller cavitation, looking aft, Run 1200

The leading edge vortex and sheet cavitation were seen consistently on all blades at this operating condition. By comparison with Run 1190, the sheet extended farther across the chord, as seen in Figure 61. Also, in contrast with the mainly cloudy appearance of the sheet seen at lower speeds, more of the sheet exhibited a transparent, glass-like appearance. The vortex cavitation from previous blades burst in the wake peak near the rudder. A particularly spectacular vortex burst can be seen in Figure 61. At this condition an intermittent hub vortex was observed, as seen in Figure 62.
